From: Rivera, Jose
Sent: Thursday, March 28, 2019 4:22 PM
To: 'sqrgroup sqrgroup'
Cc: 'angelmelendez@jca.gobierno.pr'
Subject: NEW MARITIME TRASNPORATION TERMINAL - TRANSMITTAL OF INSPECTION REPORT
Attachments: NEW MARITIME TRANSPORTATION TERMNAL - INSPECTION REPORT (FEBRUARY 2019 INSPECTION).pdf; NEW MARITIME TRANSPORTATION TERMINAL - TRANSMITTAL OF INSPECTION REPORT TO SQR (FEBRUARY 2019 INSPECTION).pdf

Attached is a copy of the inspection report that EPA issued today. The Report concerns the EPA inspection on February 19, 2019. A copy of the report with cover letter was sent to MTA.

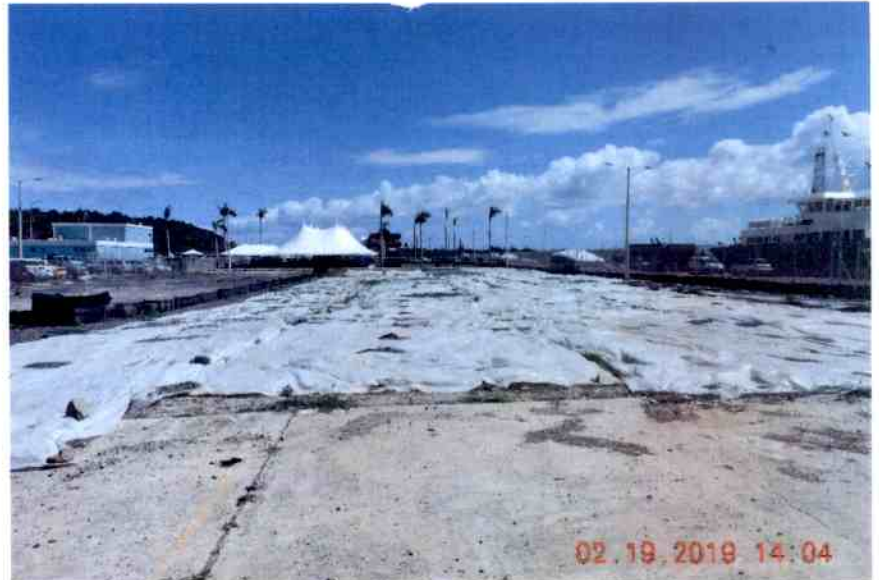
Photo 10 - This photo and the following ones depict areas of the Terminal in which plastic cover was used for temporary soil stabilization. CB 1 and CB2 are also shown.

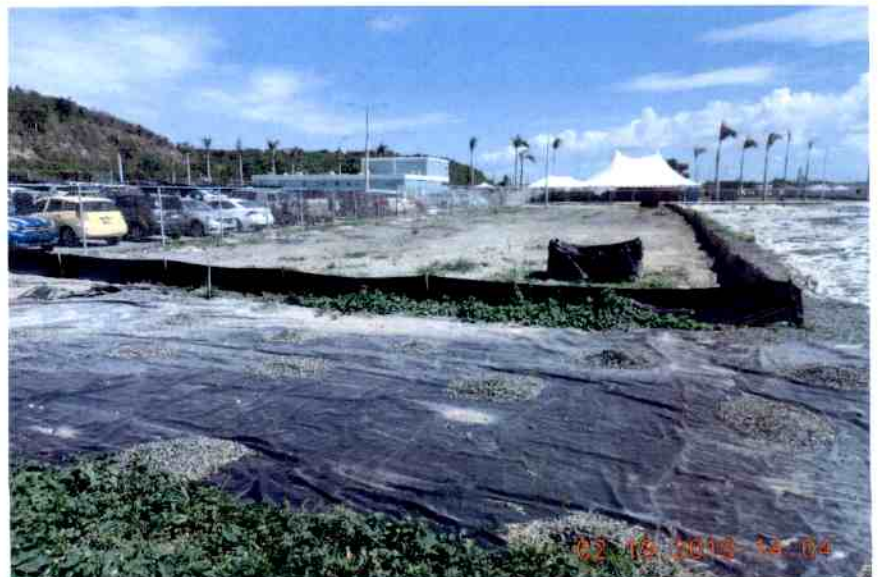
Photo 12 - See description in Photo 10. Also, this photo depicts CB1 and CB2 located in the Terminal.

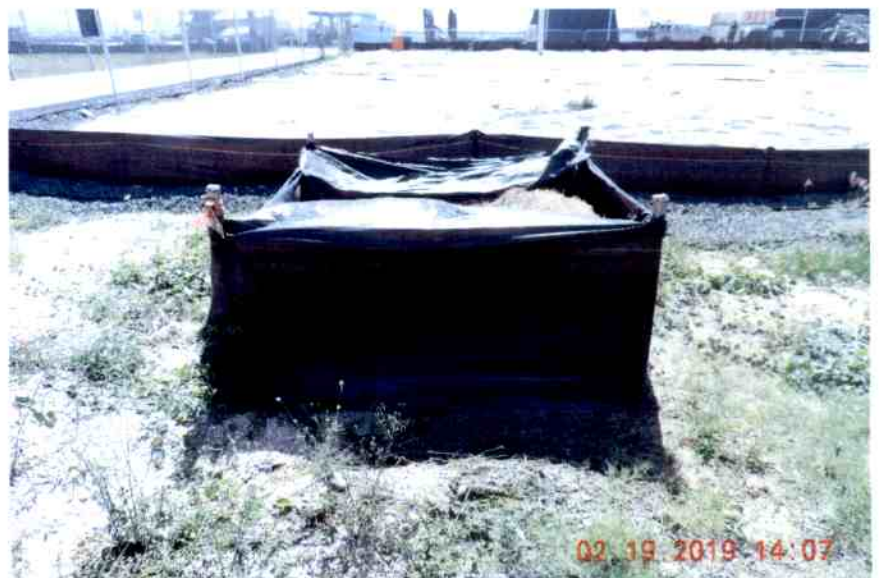
Photo 15 - This photo depicts CB1 with inlet protection.

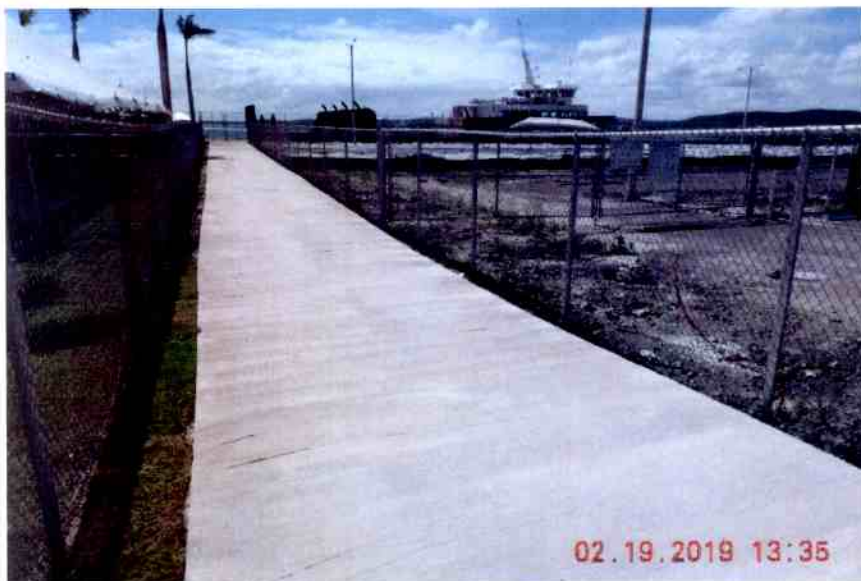
Photo 17 - This photo shows two of three inlets that were not identified in the previous two EPA inspections. The inlet to the left of the photo had final stabilization - sod, and the other one lacked inlet protection. A closer view of the inlet without protection is shown on the next photo. None of these two inlet were included in the site map included in the Stormwater Pollution Prevention Plan developed for the construction of the Terminal.

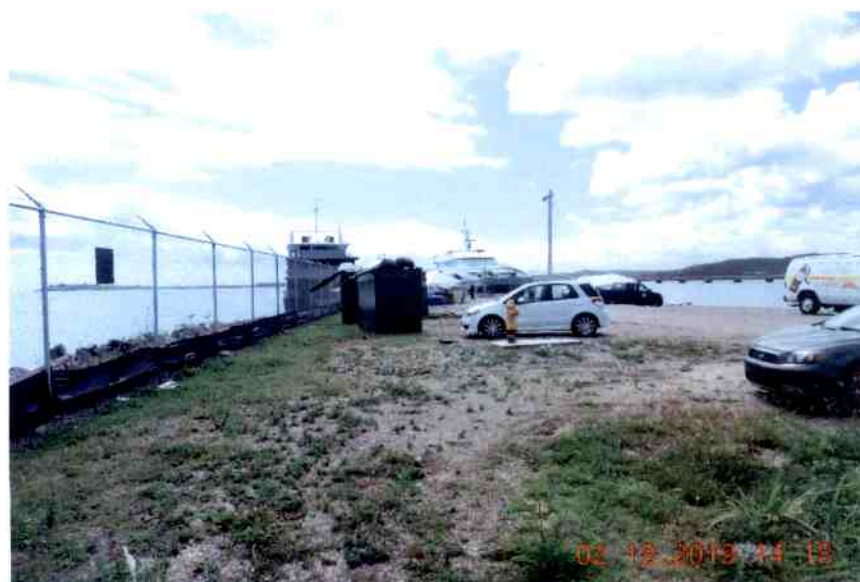
Photo 21 - View of an area of the Terminal neighboring the waterfront in which waste containers were opened to the elements. The photo depicts patches of soil without stabilization and a slit fence installed along the perimeter.

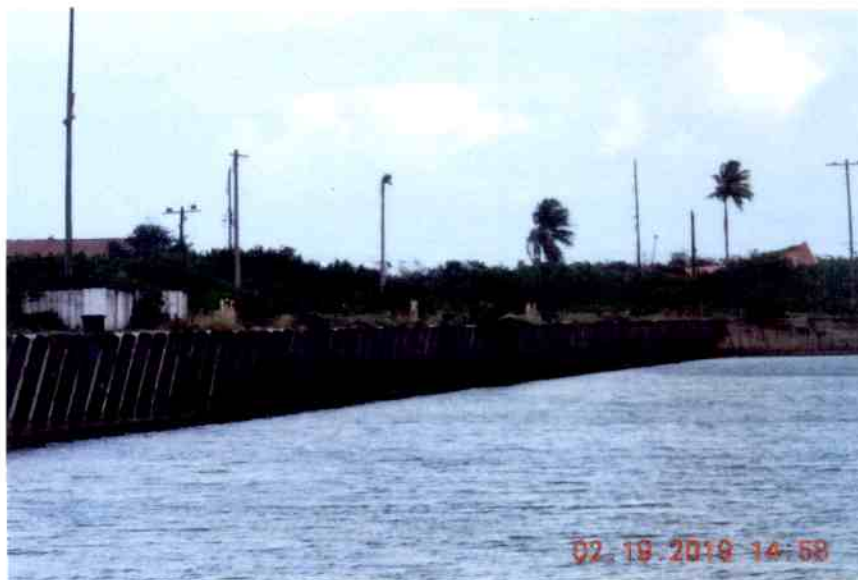
Photo 5 - This photo depicts the discharge point / outfall 003 into the Bay. A light brown discoloration plume caused is shown near outfall 003. This resulted from the water test to identify the discharge location into the Bay.

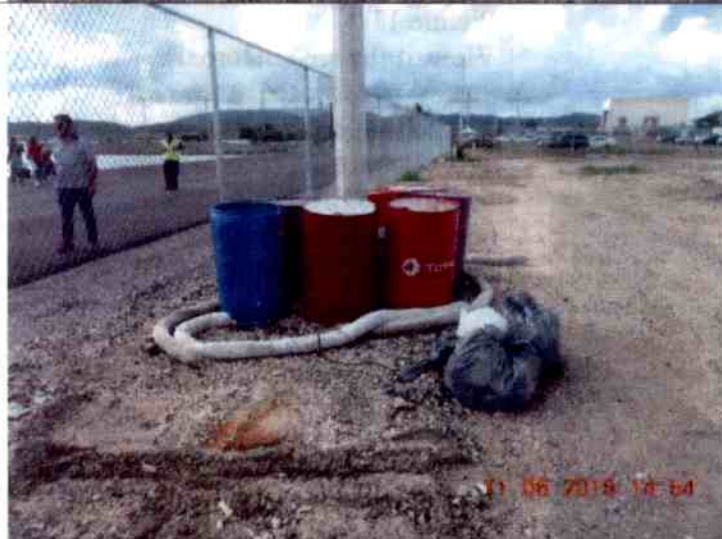
3. **Storage of petroleum products** – The EPA Inspectors observed seven 55-gallon drums placed over the ground surface without secondary containment and exposed to stormwater. Five drums were identified as hydraulic oil, one as motor oil, and one was used as a trash can. Oil booms were placed around the drums. Refer to pictures 8, 9 and 10. In addition, EPA Inspectors observed a 5-gallon bucket filled with an unknown brown liquid at the parking area to the east side of the Terminal. Refer to pictures 12 and 13.

Picture 8
View of seven 55-gallon drums placed on the ground without secondary containment and exposed to stormwater. Oil booms were placed around the drums. Picture also depicts soil without soil stabilization and perimeter without erosion controls.

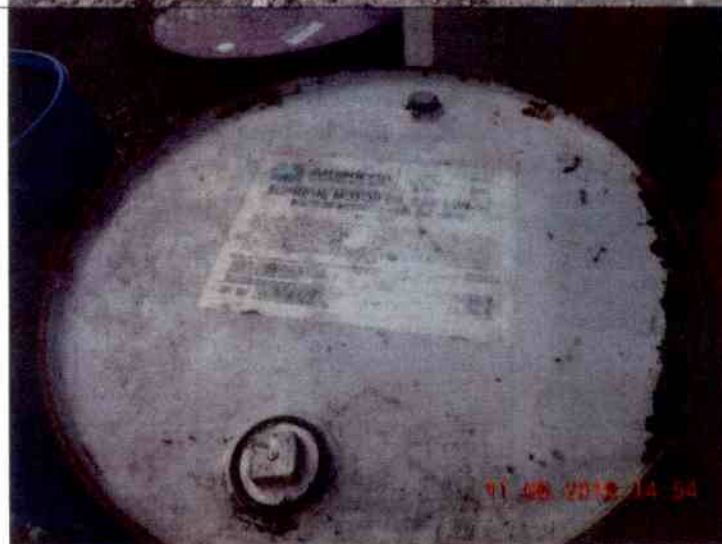
Picture 9
View of the label on the top of one of the 55-gallon drums shown in the previous picture. The label identifies the content as "supreme motor oil."

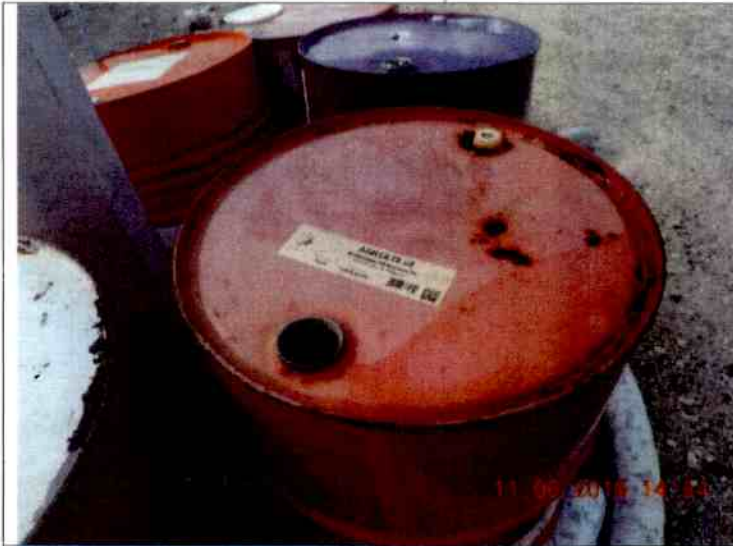
Picture 10
View of another 55-gallon drum shown on Picture 8 without the lid.

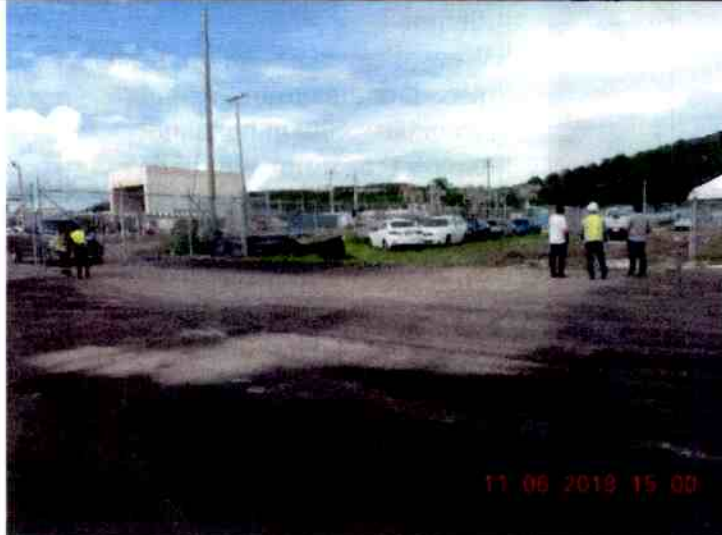
Picture 11
View of the area before the access gate located at the east side of the construction site. Vehicle tracking controls were not installed at the disturbed area prior to entering into the paved road. Tracking of sediments were observed over the road towards the access gate.

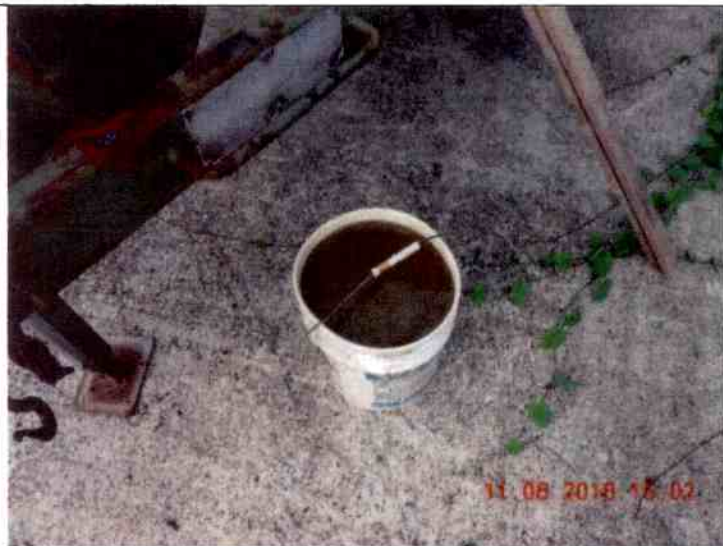
Picture 13
View of the 5-gallon bucket
filled with a brown liquid.

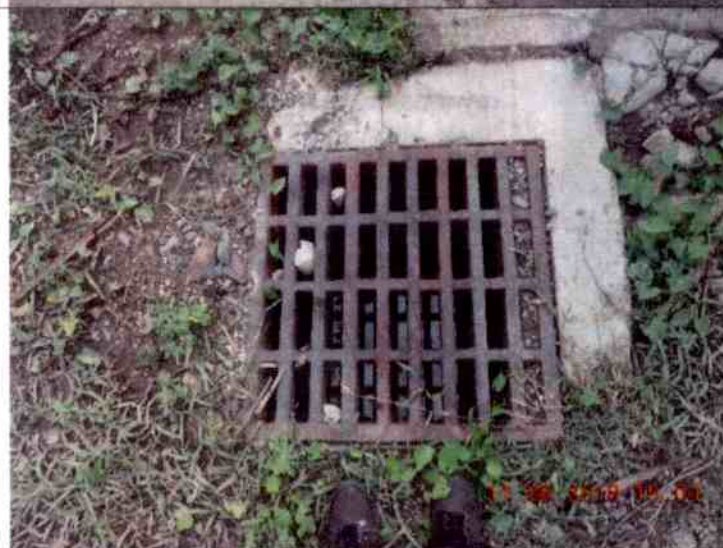
Picture 15
View of the catch basin from
the previous picture. The catch
basin was observed filled with
water of brown color, and exit
pipe could not be observed.

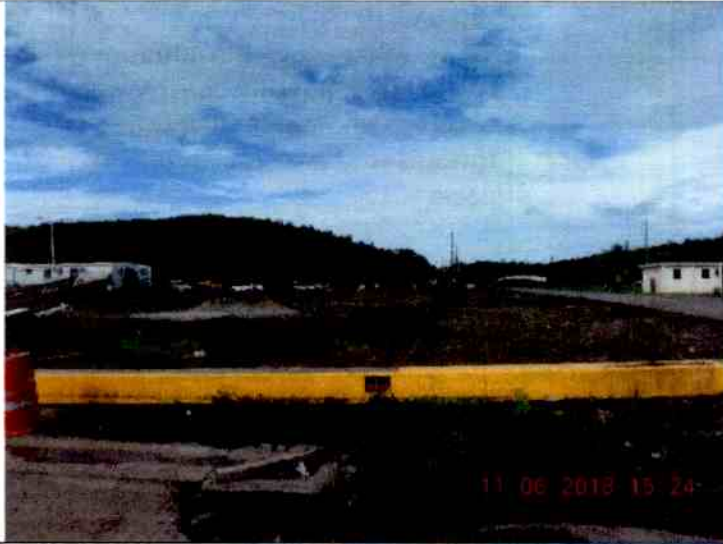
In addition, EPA Inspectors observed clearing activities at the west side of the Terminal building without sediment controls installed. Refer to picture 21.

Picture 21
View of the disturbed area at the west side of the construction site without sediment controls and soil stabilization.

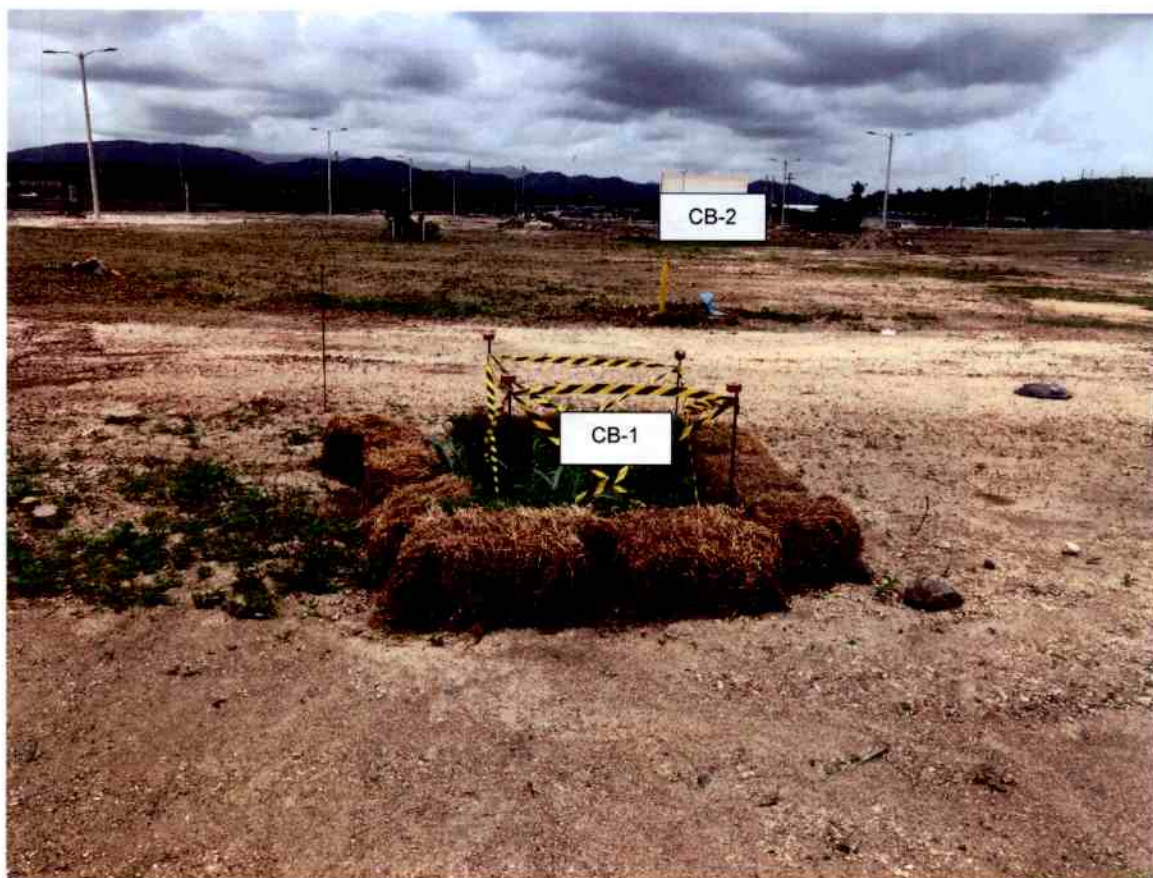
Picture 7

- a. A concrete fence was being installed along the boundary with Forrestal Road. Pre-cast concrete structures were placed on top of the ground;⁷
- b. Clearing and grubbing had taken place, and soil stabilization controls were not observed. The approximate size of the area where clearing and grubbing took place is 9 acres. **Picture 7** depicts most of the Terminal construction areas where clearing and grubbing took place, and CB-1 and CB-2;

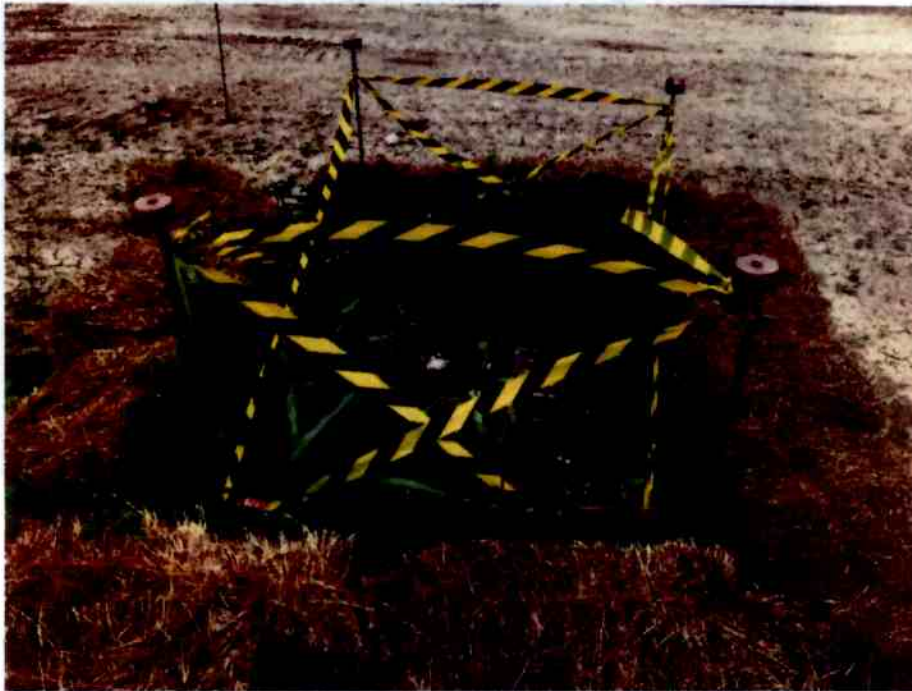
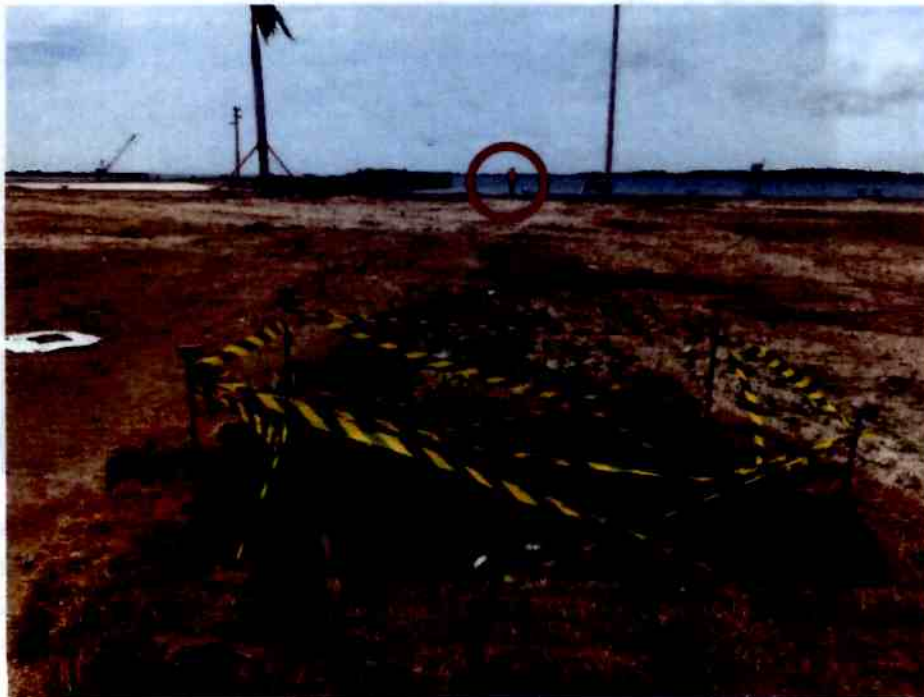
Picture 1 (CB-1)

- d. A sign was not observed depicting information about the at the construction project;
- e. As shown on Pictures 1-4, the erosion controls installed to protect CB-1 and CB-2 are deteriorated. Also, the EPA Inspector Rivera observed that both catch basin had debris and sediment accumulation;
- f. Several soil piles were observed without erosion control measures;
- g. The entrance to the Terminal construction areas was observed without off-tracking sediment controls. **Picture 8** depicts one of several soil piles without erosion control measures and the entrance;

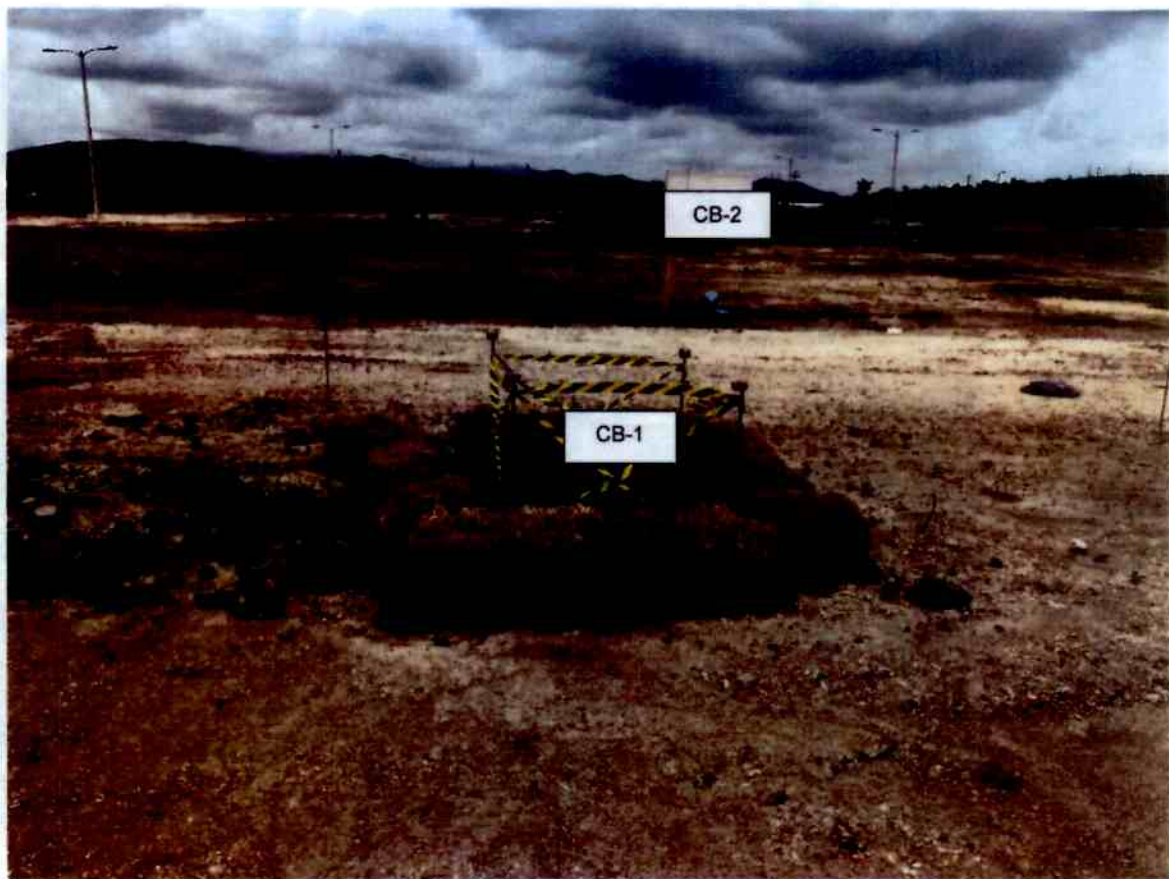
Picture 7

- a. A concrete fence was being installed along the boundary with Forrestal Road. Pre-cast concrete structures were placed on top of the ground;⁷
- b. Clearing and grubbing had taken place, and soil stabilization controls were not observed. The approximate size of the area where clearing and grubbing took place is 9 acres. **Picture 7** depicts most of the Terminal construction areas where clearing and grubbing took place, and CB-1 and CB-2;
